NEW HOME FOR RUSSIAN ICONS

Historic building gutted and re-roofed to house unique museum in Clinton, Mass.

BY PAUL FOURNIER

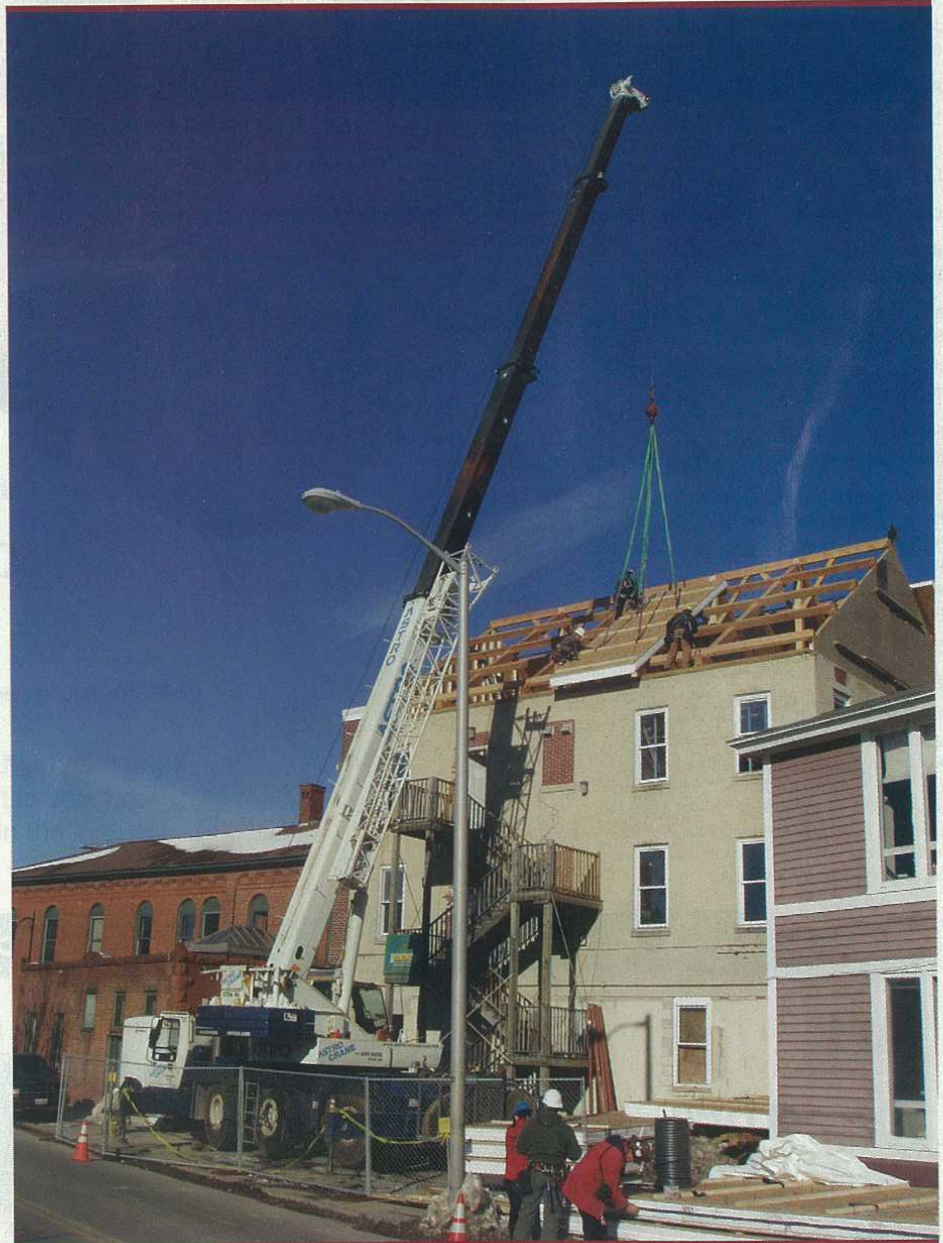
Benson Woodworking crew employs a Krupp crane provided by Astro Crane to position roof panels for Museum of Russian Icons in Clinton, Mass.

Trusses have a 38-foot span and a 9:12 pitch, and are set 8 feet 6 inches on center. They are made of solid 8-inch by 8-inch timbers that are free of heartwood to prevent checking. Benson's shop crew fabricated truss components and put them together at the Walpole yard to make sure everything fit perfectly. Then they disassembled the trusses and shipped the pieces to the job on common-carrier flatbeds. There, a Krupp truck crane provided by Astro Crane Co. of Stow, Mass., offloaded the trucks.

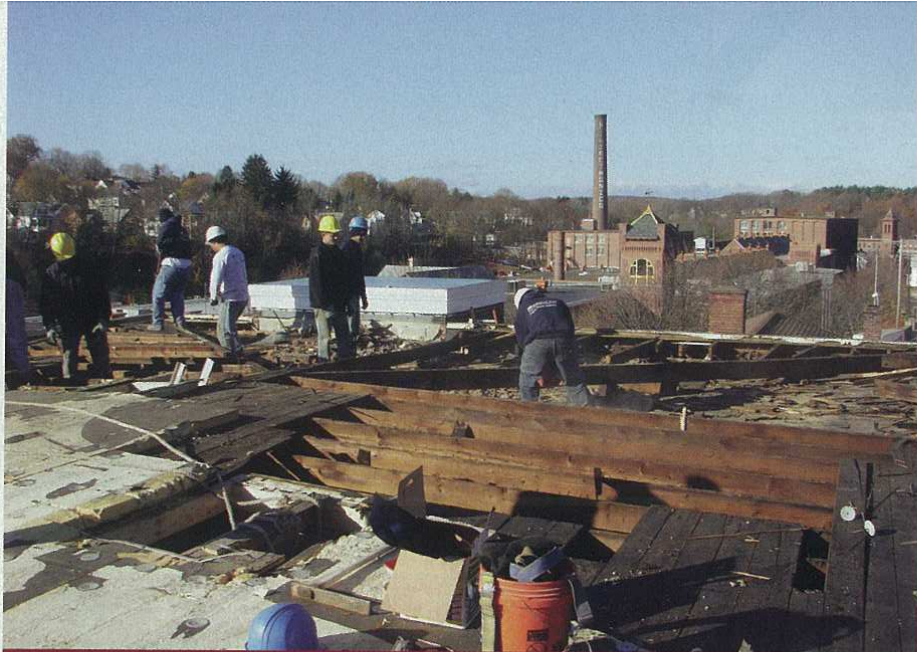
Top left: Murray Brothers Construction workers demolish roof of old mill building being converted into museum.

Middle left: With roof demolished, workers reinforce existing wall frames and place new roof plate on walls.

Bottom left: Photo of front of building shows three trusses and one gable in place.

tube columns. The Leominster company also fabricated the two end gables, and installed new, 2-inch by 14-inch glued laminated timber roof plates on the perimeter bearing walls to support new roof trusses.

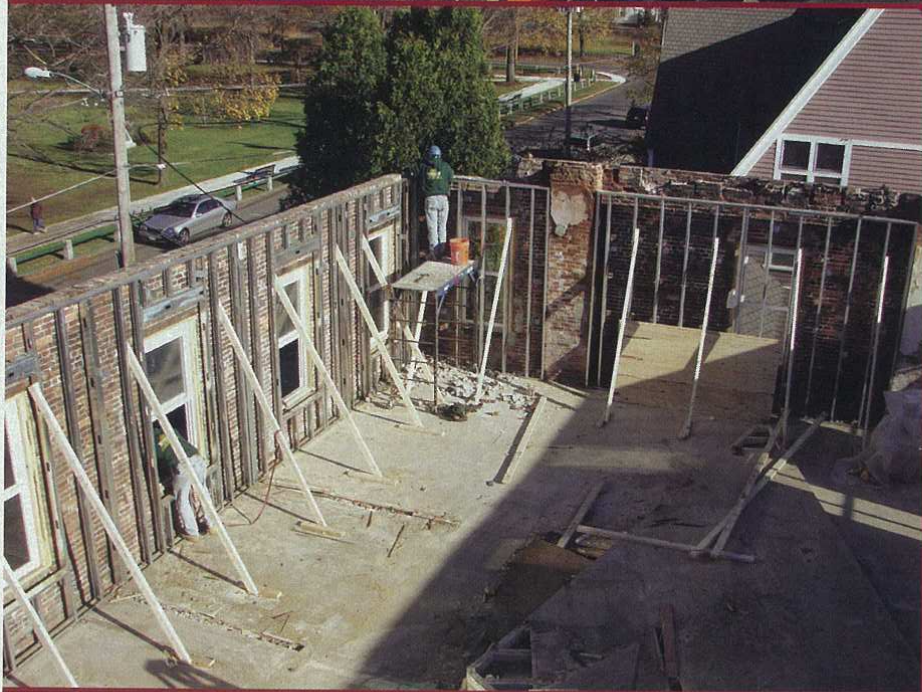
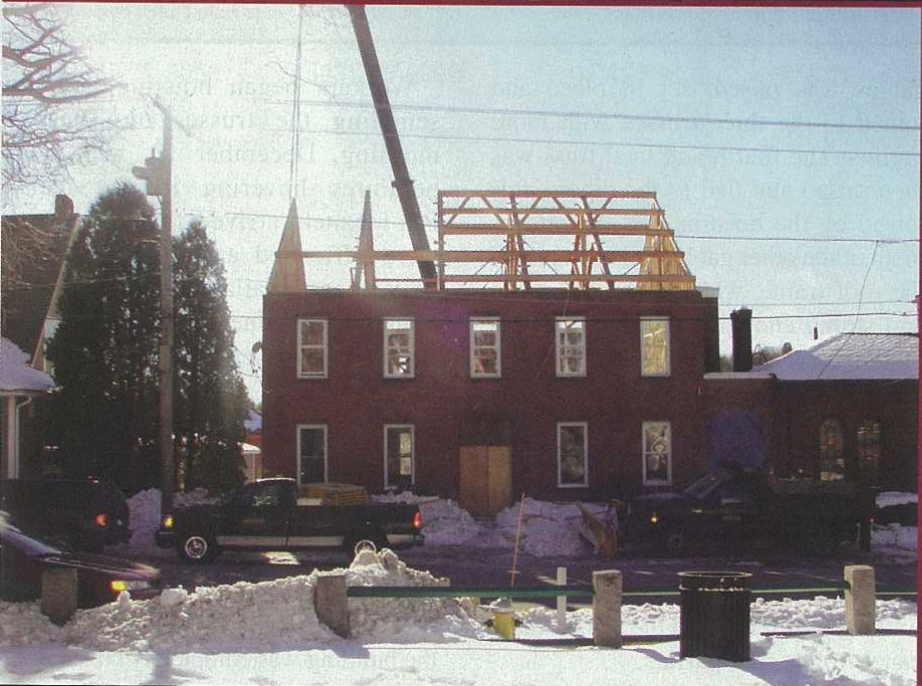
For lack of space, gable end walls were fabricated on third floor, then lowered to alleyway at street level until ready for final positioning.

Since there was not enough room at street level to assemble the trusses, the components had to be lifted to the third floor where workers assembled each truss. And the 38-foot by 44-foot floor area precluded doing more than one. Once assembled, each truss was lowered to the alleyway between the museum and neighboring buildings.

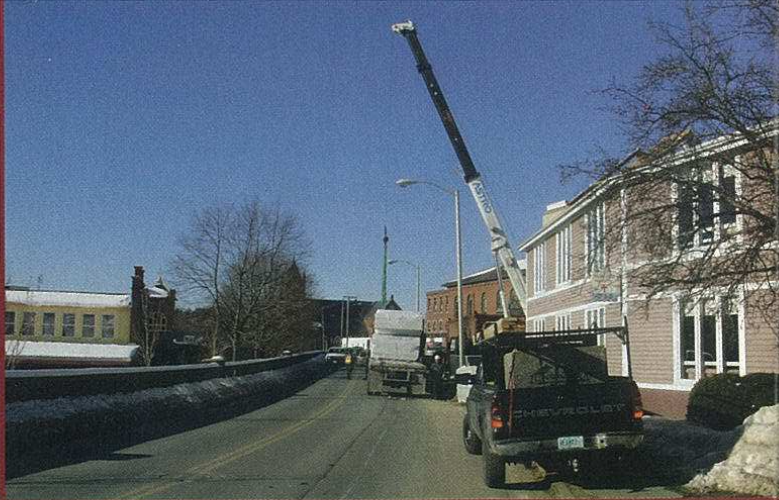
Police detail closes off one-lane of narrow section of Route 62 as crane unloads pallet of prefabricated roof panels.

"This is a very tight site," explained Ben Brungraber, professional engineer for Benson who designed the trusses and planned the construction procedure. "We have to have a police detail on the job while the crane is offloading and raising trusses and roof panels, because sometimes one lane of two-lane Route 62 has to be shut down."

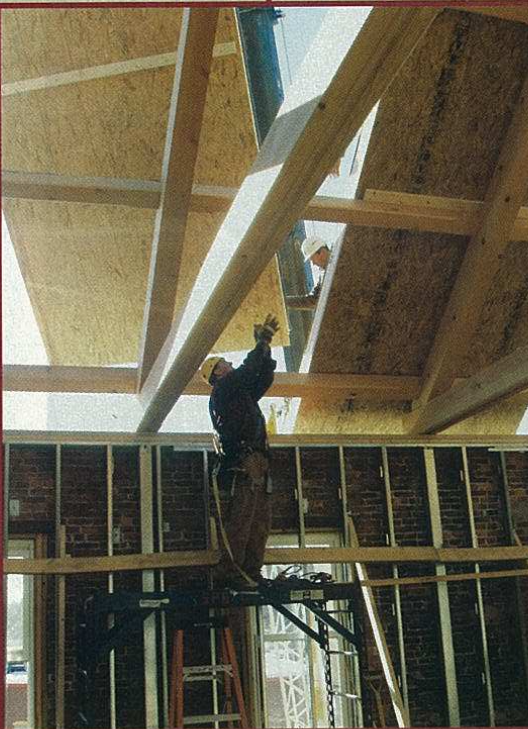
Workers guide an 8-foot by 24-foot roof panel into position on purlins.

Roof panels, measuring 8 feet by 24 feet, are made of 1/2-inch-thick OSB wood skins that sandwich an 8-inch-thick expanded polystyrene foam insulation. Panels are rated at R-30. Gaskets plus OSB splines are wrapped around each panel ensuring air-tight seams. Extra long screws hold the 9-inch-thick panels to the roof purlins.

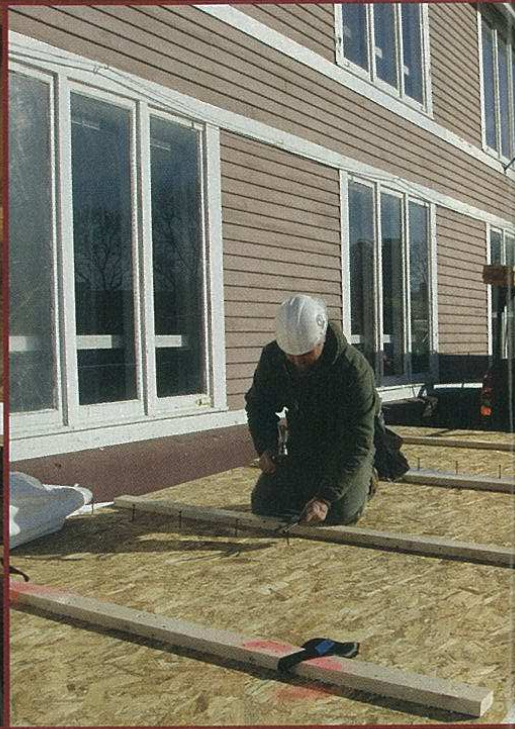
Duane Beiler pre-installs extra-long screws that will later be driven to hold panels to purlins.
